NACA TN 3190

TECHNICAL NOTE 3190

FATIGUE INVESTIGATION OF FULL-SCALE  
TRANSPORT-AIRPLANE WINGS

SUMMARY OF CONSTANT-AMPLITUDE TESTS THROUGH 1953

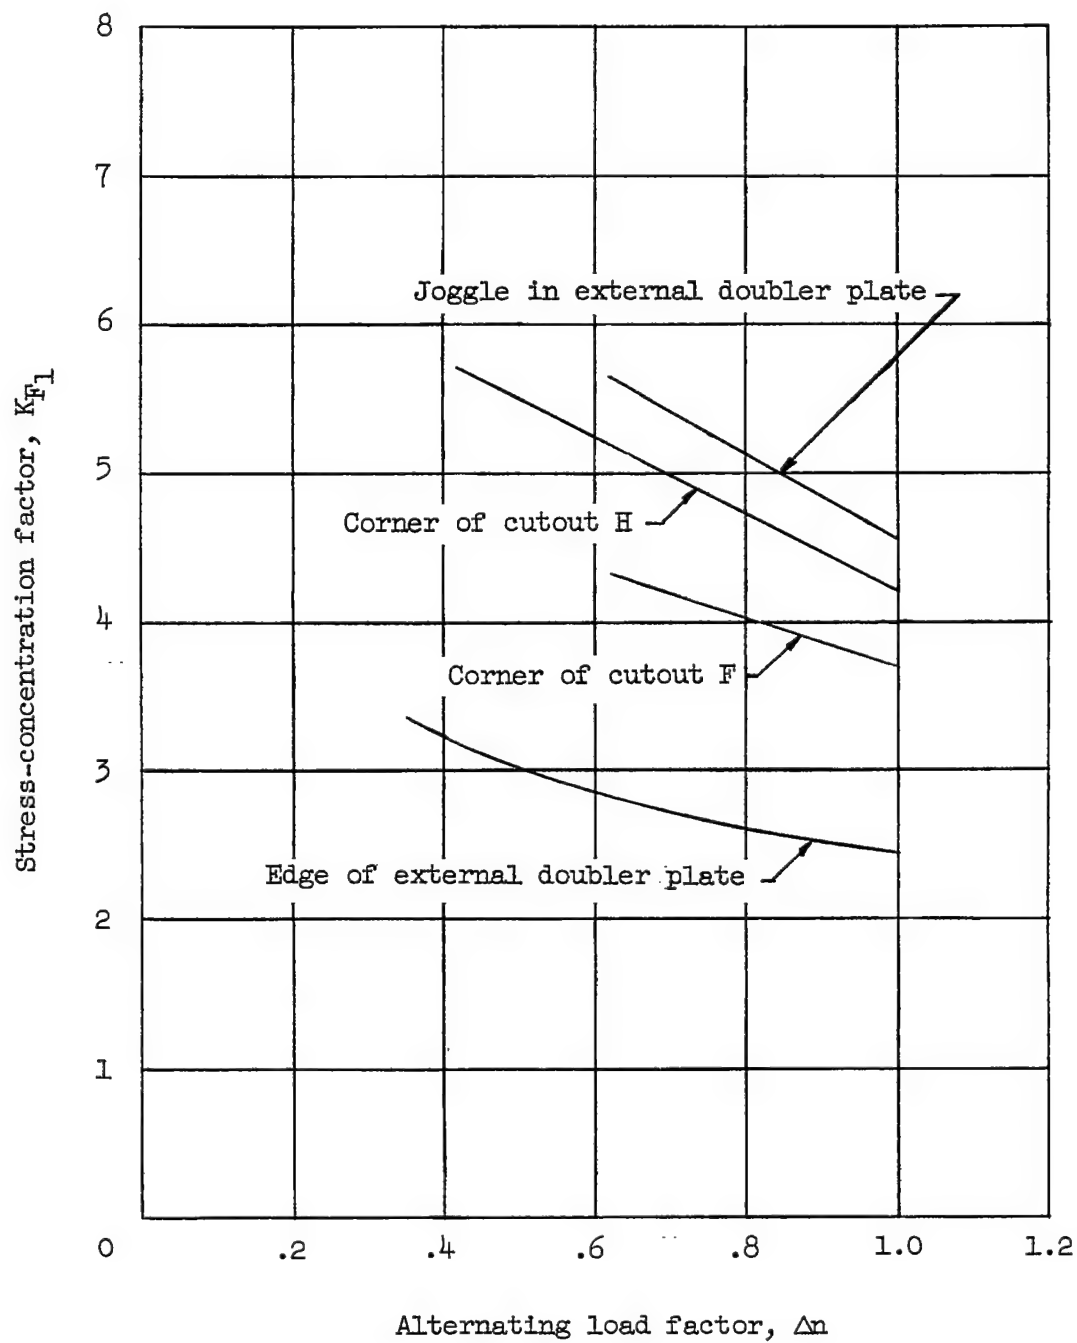
Figure 10.- Effect of load level on the stress-concentration factor.

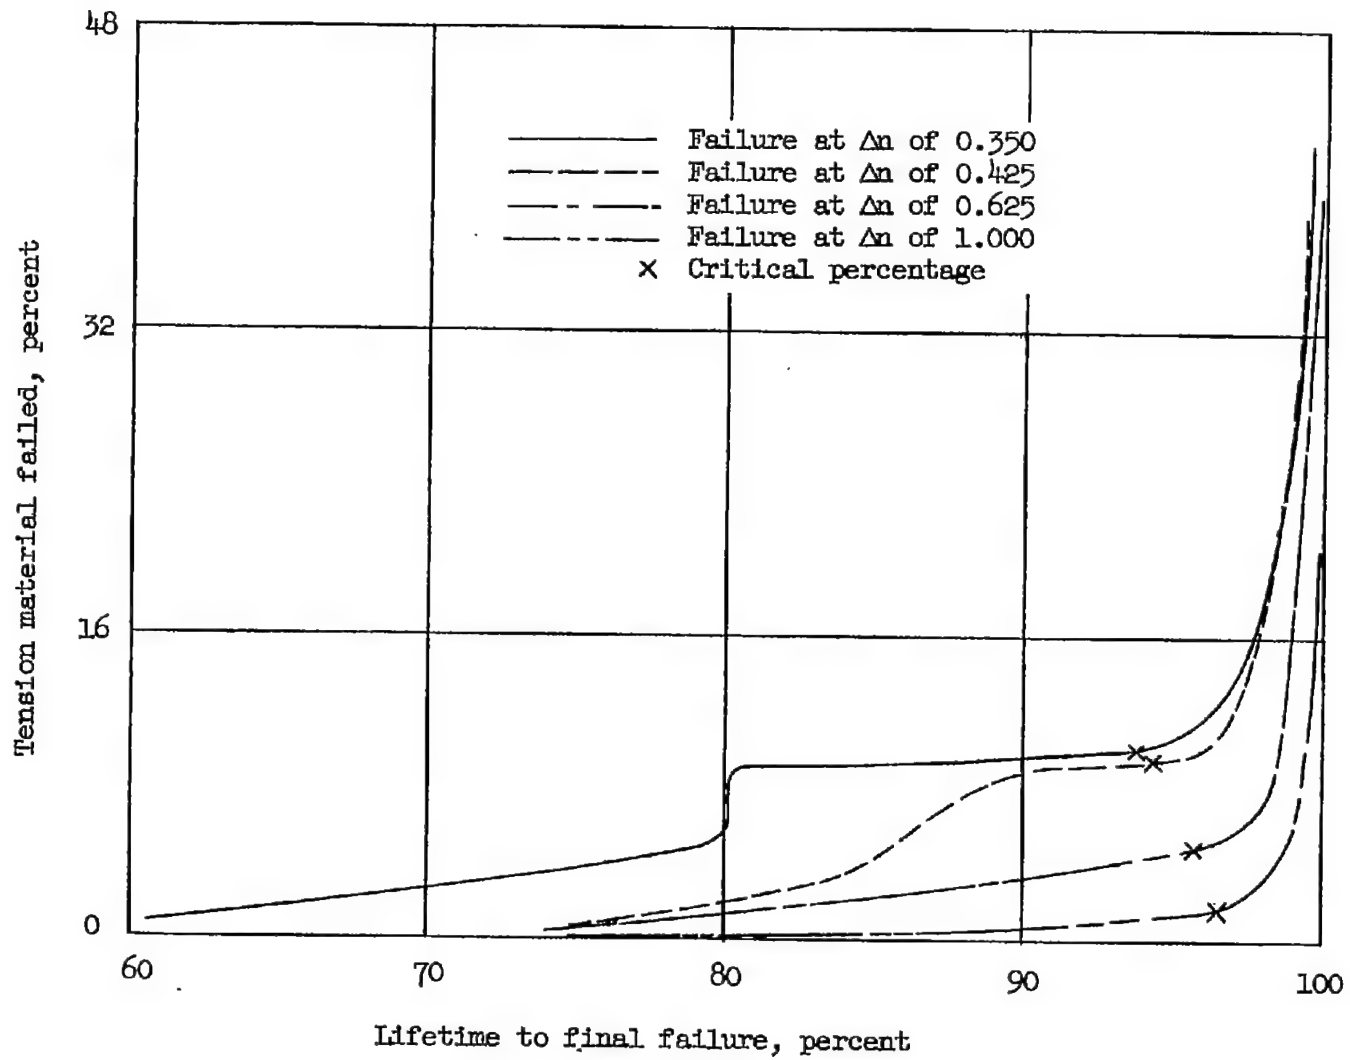
The growth of all fatigue cracks was observed during the course of the tests. In figure 11 the growth of typical failures is plotted for each of the test levels. In order to put all failures on the same comparative basis, the percentage of tension material failed in a cross section of the wing is plotted against the percentage of lifetime to final failure. In this figure it can be noted that all of the curves have the same general shape. In each case the failure grew slowly until a certain percentage of the tension material had failed. At this point, defined as the critical point, the growth of the cracks became very rapid. The percentage of tension material that had failed at the critical point decreased with increasing load level. For the 0.35g level the amount of tension material that had failed at the critical point was about 10 percent; for the 0.425g level, about 9 percent; for the 0.625g level, about 6 percent; and for the 1.0g level, about 2 percent. This critical point occurred at about 95 percent of the lifetime to final failure for all test levels. Tests of all specimens were continued until the critical point had been determined.

Figure 11.- Typical fatigue-crack propagation.

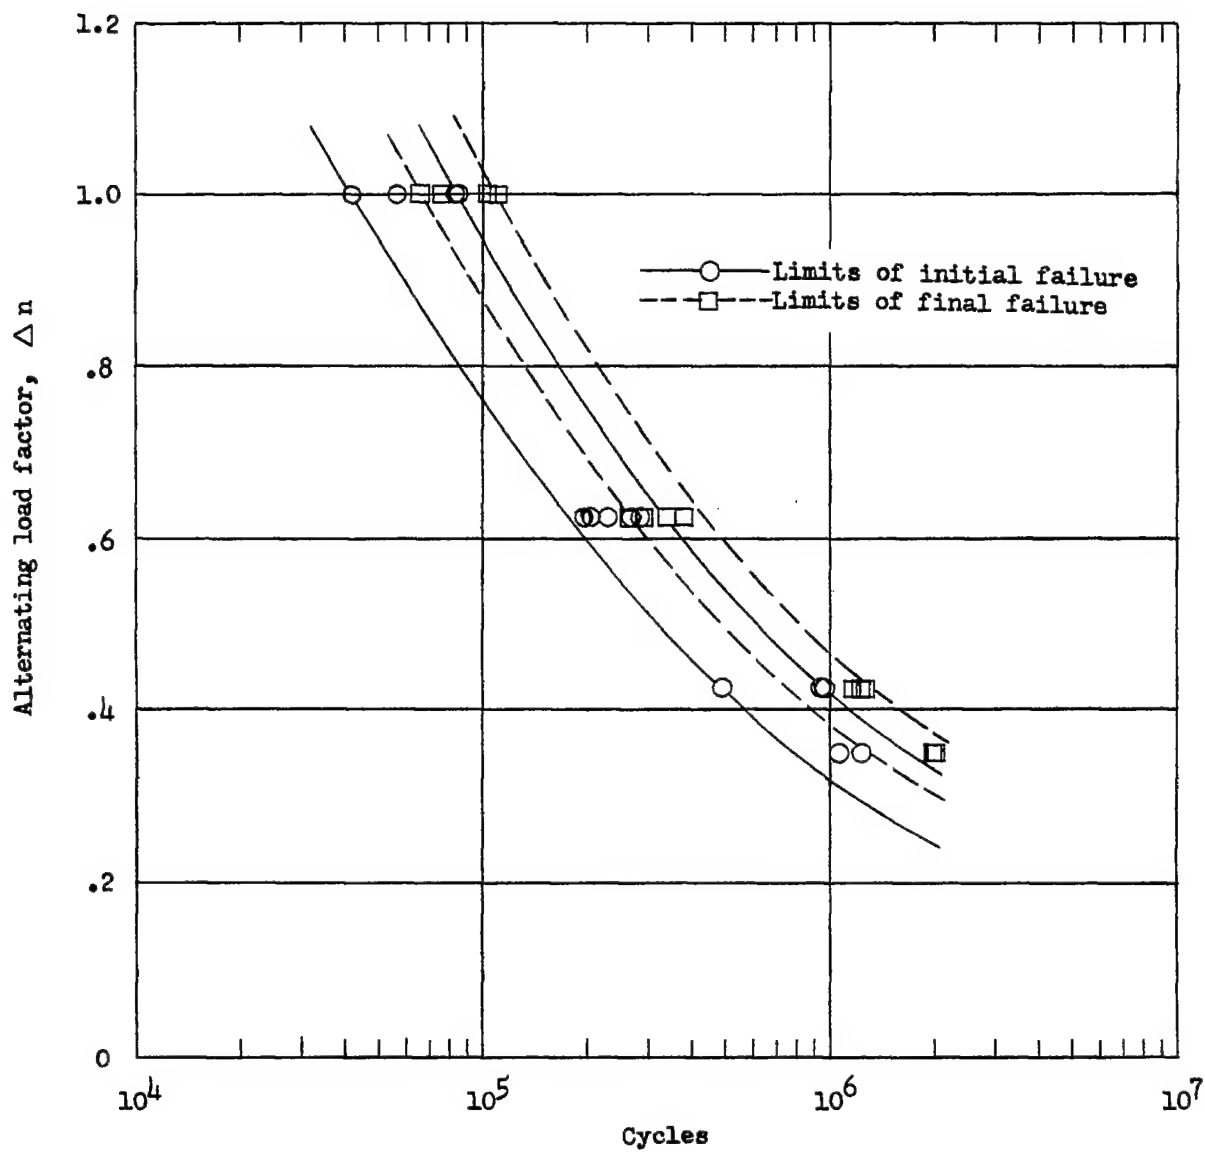
Figure 12.- Load-lifetime diagram for failures that grew past the critical point.

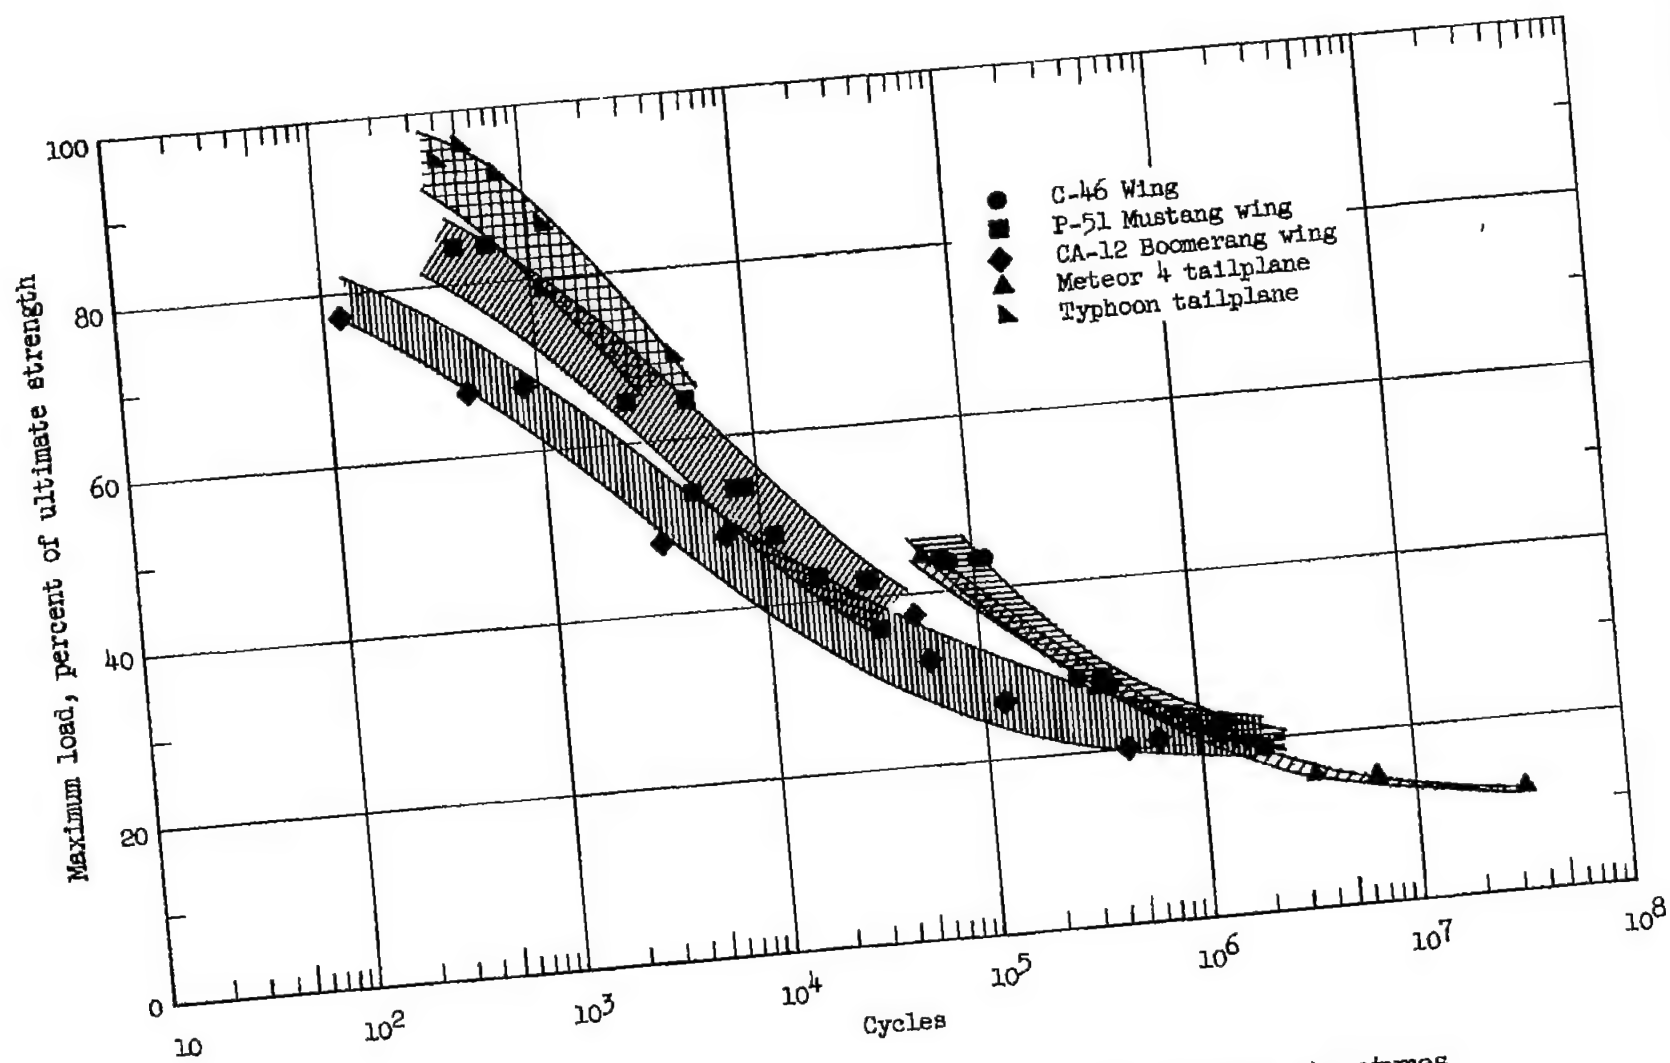
The load-lifetime diagram for final failure is presented in figure 13, along with results of fatigue tests on a number of other airplane structures taken from references 7 to 10. The load is given in percent of the ultimate static strength of the structure. It can be seen from this figure that all of the full-scale data presented lie within a comparatively narrow scatter band, considering the fact that the data include different types of airplanes and components with many types of stress raisers. Full-scale fatigue data from other airplanes have been found to fall within the scatter of the data that are presented.

Since the ordinate of figure 13 is based on the ultimate strength of the structures and since fatigue failures occurred principally on the tension surface, the load-lifetime comparison could best be made on the basis of the ultimate strength of that surface. In the static tests to determine the ultimate strength of the structures in references 7 to 10, the P-51 wing and Meteor 4 tailplane failed in compression while the remaining structures failed in tension. The C-46 curve in this figure is based on the design ultimate strength of the wing, because the actual ultimate strength is unknown. In static tests performed by the U. S. Air Force the wing failed in compression at 95 percent of the design ultimate load, and was subsequently reinforced but not retested.

If, in the case of those structures which failed in compression, the strength of the tension surface is assumed to be greater than the strength used in the comparison of figure 13, the load-lifetime curves would be shifted downward. This downward shift would very likely result in even less scatter in the data of this figure than is now present.

Figure 13.- Load-lifetime diagrams for several aircraft structures.

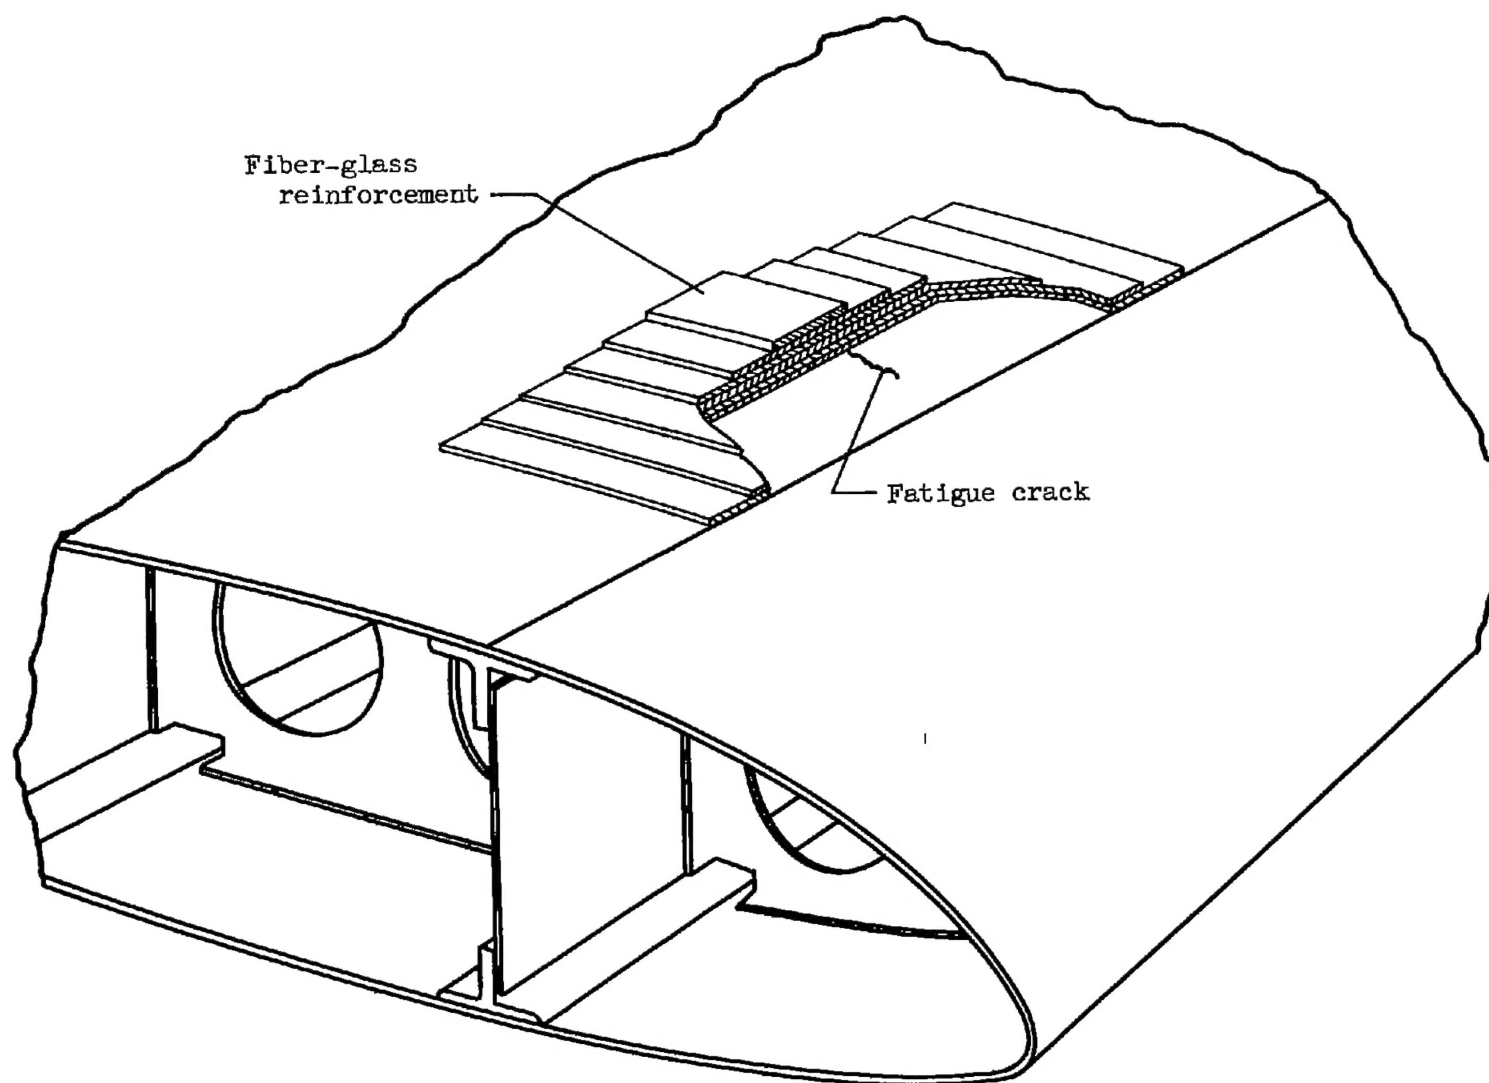
Figure 16.- Typical arrangement of fiber-glass reinforcement.

All fatigue cracks which were repaired by this method extended in essentially a chordwise direction on the tension surface of the wing. The patches were therefore designed principally to carry tension loads in a spanwise direction. For these fatigue tests the tension surface of the wing was the upper surface since the wing was mounted in the inverted position. The size of the patch required for satisfactory reinforcement naturally depended to some extent on the size of the fatigue crack to be repaired. The length and width of the reinforcement were determined by a generous estimation of the bond area necessary to secure adequate transfer of load from the wing structure to the fiber-glass reinforcement. Since the modulus of elasticity of the reinforcing material was considerably less than that of the aluminum wing structure, the thickness of reinforcement used was about five times the thickness of the structure to be repaired, so that both had about the same stiffness. All reinforcements were laminated from 10 to 16 layers of fiber-glass cloth arranged in a tapering stack which reached its maximum or design thickness over the fatigue crack. This arrangement is shown schematically in figure 16.
